### Technical Bulletin

ATS-137-4  
2013-01-15

#### NEW IMPROVEMENTS IN THE APPEARANCE OF INSTALLED Pilkington **Energy Advantage™** Low-E Glass

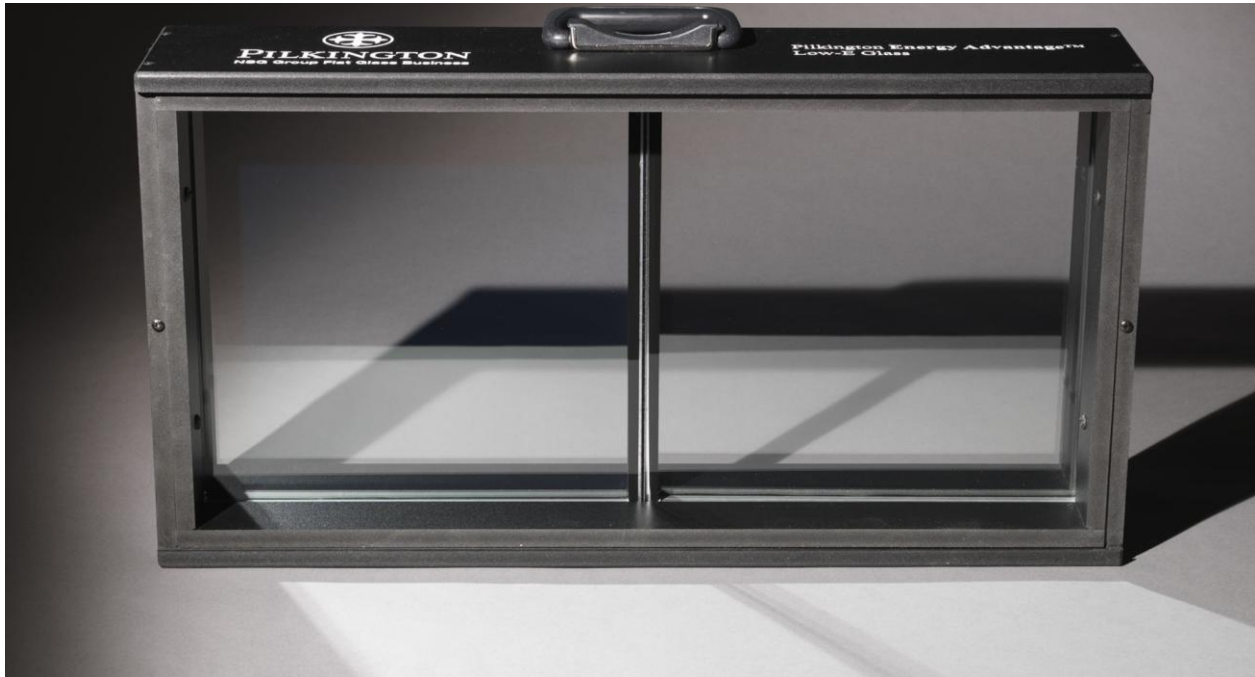
Pilkington **Energy Advantage™** is made of an extremely fine polycrystalline hard material that cannot be seen under most lighting and viewing conditions. It is possible to discern the presence of the coating under certain lighting conditions, such as when bright sunlight shines directly onto partly shaded, coated glass and there is deep shade on both sides of the glass.

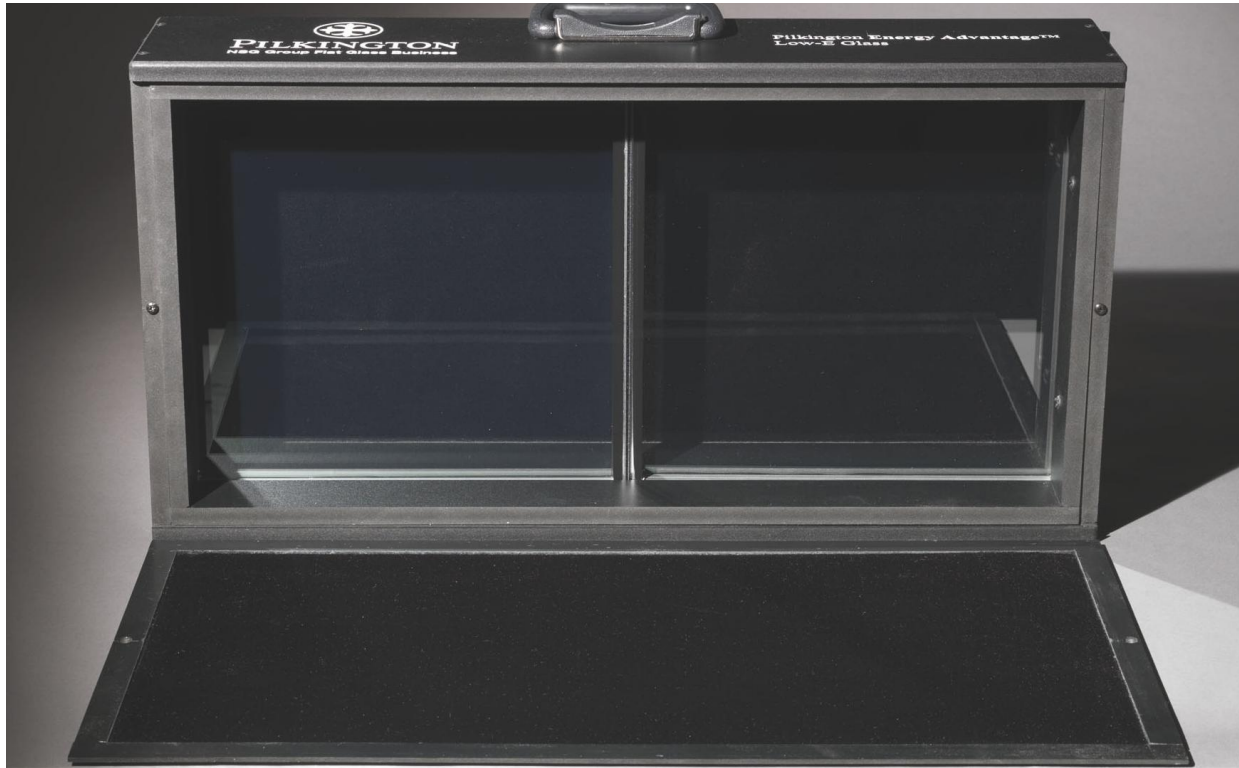
Using extreme lighting conditions for the reflected images of a typical window, the residual haze of the older (2010 and earlier) product can be seen in the left hand IG unit of the following photo. A studio spotlight simulates direct sunlight (with the same set-up as in the photo above), and eliminating (with black velvet) the distracting transmitted and reflected images of a typical window, the residual haze of the older (2010 and earlier) product can be seen in the left hand IG unit of the following photo. The IG unit on the right hand side of the original photo below barely shows the miniscule amount of haze that can be found in 2011 production of 2.5, 3.0 and 4.0 mm thick Pilkington **Energy Advantage™**.

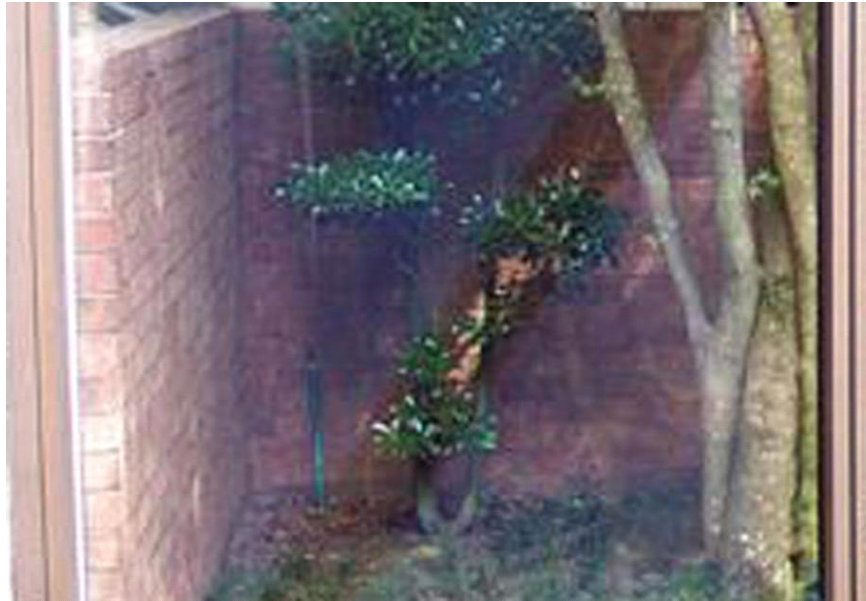
It is possible to discern the presence of the coating under certain lighting conditions, such as when bright sunlight shines directly onto partly shaded, Low-E coated glass and there is deep shade on both sides of the glass. When looking out through the glass towards a deeply shaded background, the short wavelength component (blue) of the sunlight appears slightly scattered. This gives the coating a uniform, very faint blue appearance visible in the sunlit area. Longer wavelength red light is less scattered. In the 2003 photo below the haze was made more noticeable by the complete lack of any visible haze in any contrasting glass shaded areas, such as in the diagonal shadow on the glass.

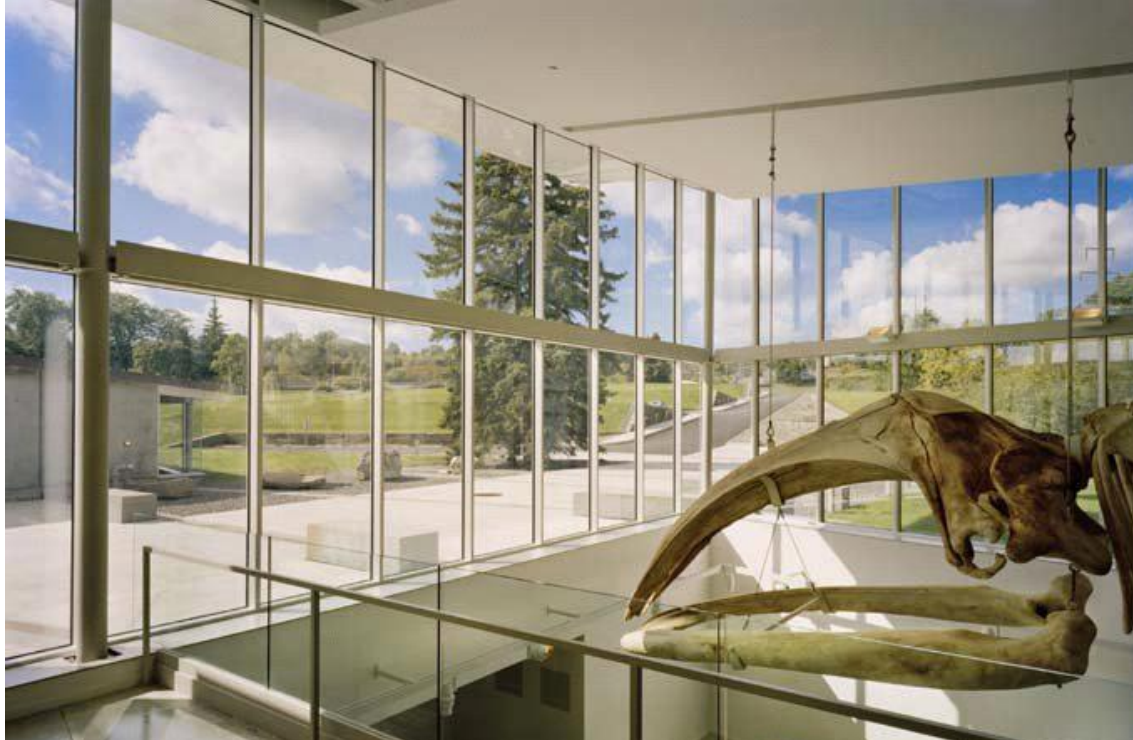
The following photo is an example with no visible haze, even in the sunlit Pilkington **Energy Advantage**<sup>™</sup> Low-E Glass (pre 2011 production), because there is no deep shade beyond the glass.

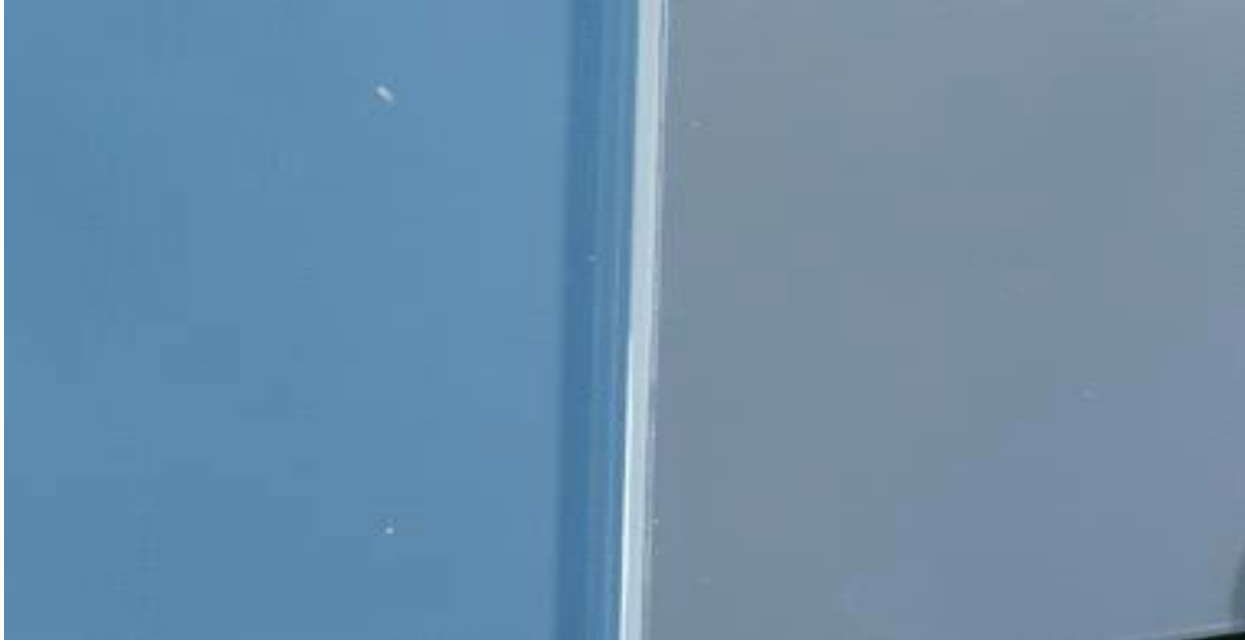
An alternate way to achieve the very high thermal insulation provided by the pyrolytic 'hard' Low-E coating in a double glazed unit, is to use a 'soft' sputtered coating produced off-line in a vacuum chamber. Such coatings must be protected from humidity by being sealed into an IG unit. The sputtered coating is typically removed or ground off at the perimeter to allow effective insulating glass sealant adhesion. Sputter coatings usually have some reflected color as seen in the left hand glass (1).

Sputter coat IG reflected color of a grey sky. The same sky reflected in adjacent clear glass IG

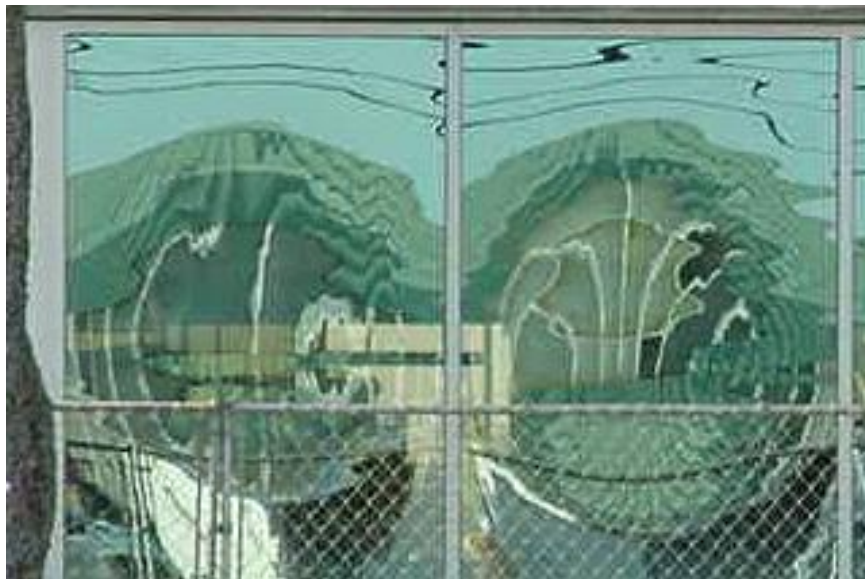
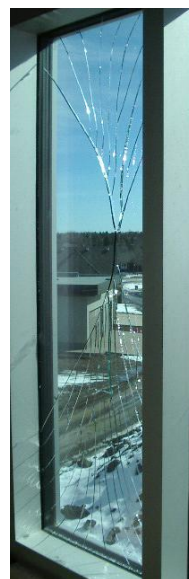
The use of three lites of plain glass in a triple glazed unit can also give insulation values similar to a double glazed unit with a low-e coating. But this involves a thicker and heavier window unit, with increased reflectivity, and more distortion in the reflected images when weather changes cause greater expansion and contraction of the wider total air space. There is an increased risk of breakage with improperly balanced air spaces, compared to sealed double glazing.
