## THERMAL STRESS

**ATS-123**

**09/2026**

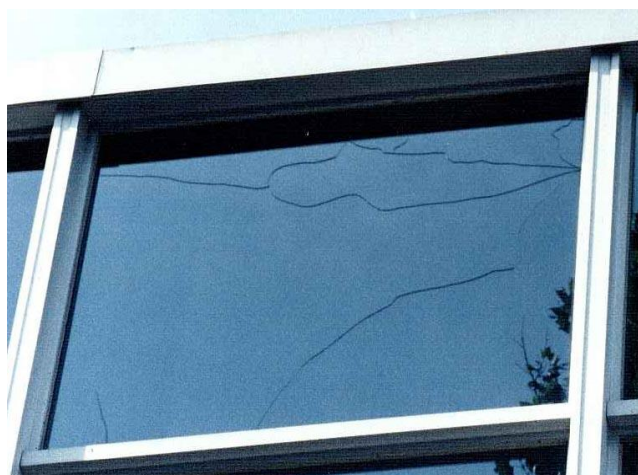
Typical, high stress fracture, originating at the right-hand side. In this case insulation behind an annealed, heat absorbing glass and the shadow from an overhang caused excessive stress on a clean-cut edge.

When the glazed edge of a window light is shielded from sunlight by the frame, this covered edge will generally be cooler than the central area which is exposed. The expansion of the central warm area will be resisted by the cool edge. Typically, the hotter exposed area is much larger than the cooler edge area and so the edges are stretched into a state of tensile stress of about 50 psi (pounds per square inch) for every degree °F difference between the center and the edge. On a calm day, sunlit heat-absorbing window glass can easily reach 40°F above the ambient air temperature. The covered glass edge temperature will be somewhere between that of the ambient air and the exposed glass. The frame detail determines how much heat reaches the edges; e.g., a deep concrete frame insulates the edges, while structural silicone glazing allows edge heating almost equal to that at the exposed area. In the example above with 40°F temperature difference a stress of 40°F x 50 psi / °F or 2000 psi will be developed if the edge is fully insulated from direct solar heating.

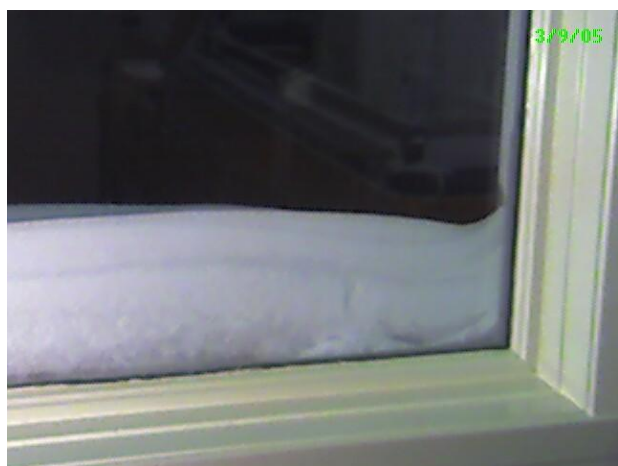
1. Large horizontal sills in front of vertical or sloped heat absorbing glass where snow can accumulate. When the exposed portion of the glass absorbs sunlight a large temperature difference can easily develop between the exposed area and the portion of the glass shaded and cooled by the snow.

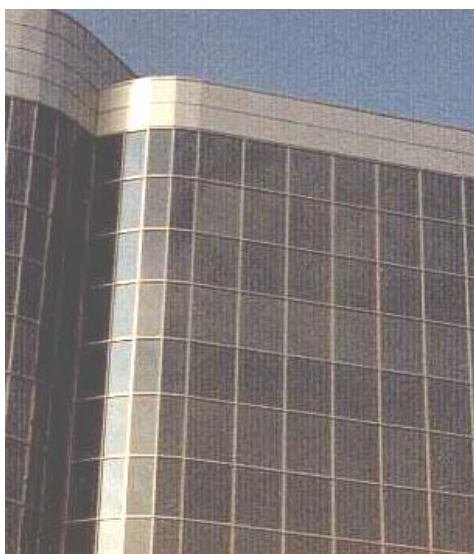
3. Inside corner reflections (where two curtain wall sections meet at a 90 deg angle, measured on the exterior, in plan view) cause increased temperature differences in glass when the heat from the grazing solar reflection of an adjacent glazing is added to the direct solar radiation.
