## ENERGY EFFICIENT WINDOW DESIGN WITH MULTIPLE LOW- EMISSIVITY COATINGS

**ATS-138D**  
**09/2026**

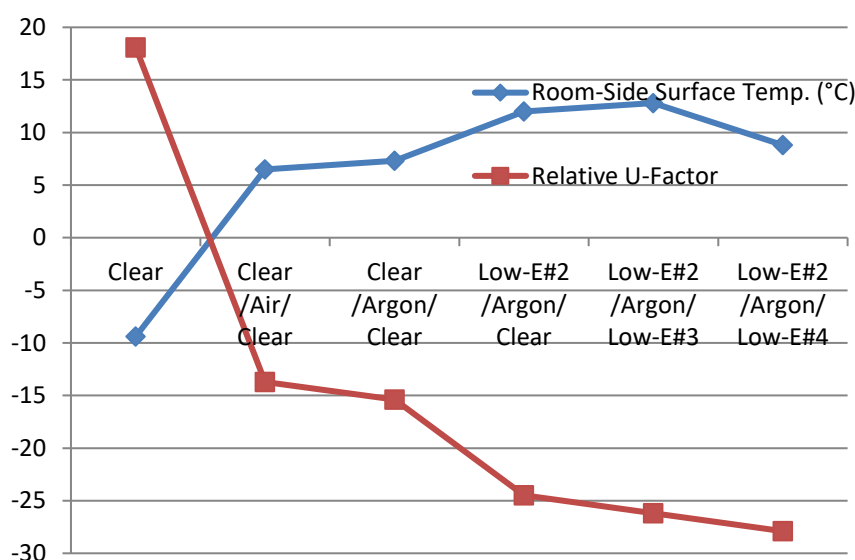
The graph below shows the Relative U-Factors (no units) and the room-side surface temperatures (°C) during ASHRAE/NFRC standard winter conditions of -18°C (0°F), and 5.5 m/s (12.3 mph) wind for different coating combinations. The graph shows the significant further gain in U-Factor achieved by the addition of a second low-e coating to a DGU.

The central glass area of a clear, non-coated, air-filled, properly manufactured, double glazed unit, with 12 mm (1/2 in.) air space has been demonstrated over the years to be warm enough to prevent center of glass condensation in normal residential winter conditions in North America. With this as a datum point it can be seen that adding low-e to the #4 surface of a low-e (#2 surface), Argon filled, IG unit will result in a slightly warmer center of glass area and even less possibility of condensation occurring there.
