## 4<sup>TH</sup> SURFACE LOW-E COATINGS: GUIDELINES FOR USE

**ATS-193**  
**09/2026**

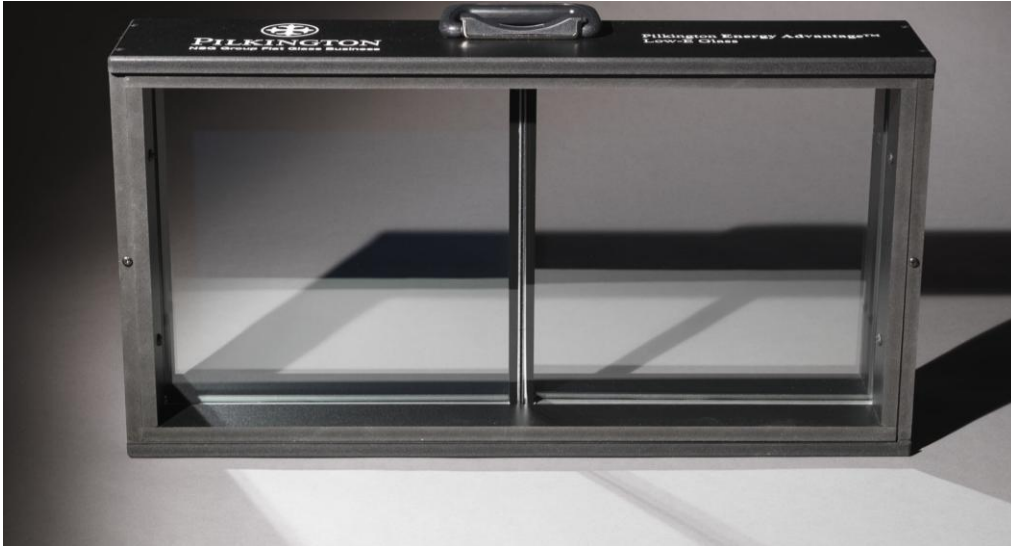
Improvements made to the Pilkington **Energy Advantage™** coating have significantly reduced visual haze, giving unrivalled clarity in a pyrolytic product as shown below. These improvements are detailed in Architectural Technical Bulletin ATS-137.
